# WASTE HOUSE RUN NO. 3 DAM

NDS ID NO. PA-684

## PHASE I INSPECTION REPORT NATIONAL DAM INSPECTION PROGRAM

PHASE I  
NATIONAL DAM INSPECTION PROGRAM  
WASTE HOUSE RUN NO. 3 DAM  
NDI. I.D. NO. PA 684  
DER I.D. NO. 54-26

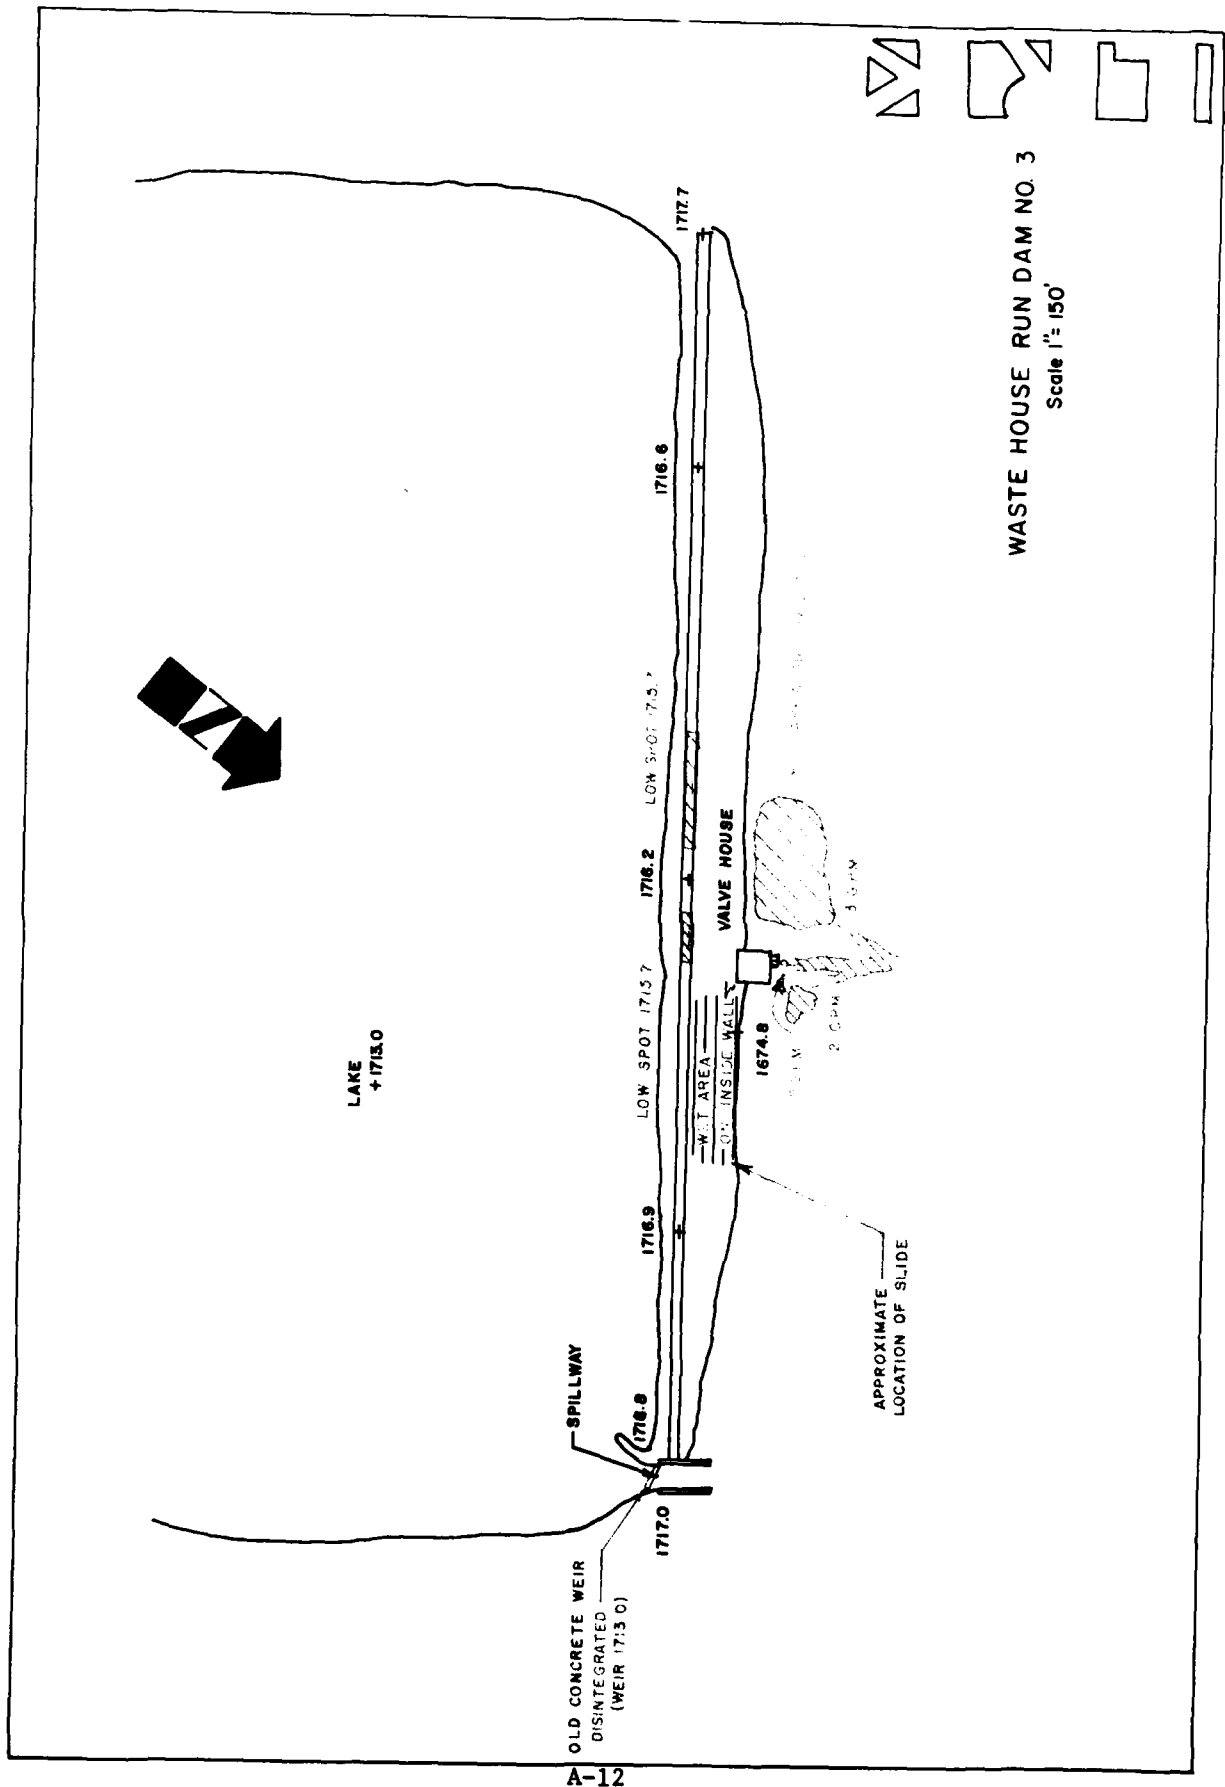
A-12

VISUAL EXAMINATION OF	OBSERVATIONS	REMARKS OR RECOMMENDATIONS
SURFACE CRACKS	None noted.	
UNUSUAL MOVEMENT OR CRACKING AT OR BEYOND THE TOE	There is some unusual slope movement on the downstream slope to the right of the valve house. This is evident by thickening of the stone rubble and a horizontal lineament.	
SLOUGHING OR EROSION OF EMBANKMENT AND ABUTMENT SLOPES	See above.	
VERTICAL AND HORIZONTAL ALIGNMENT OF THE CREST	Horizontal appears to be good. Vertical alignment spot. See page A-12.	low
RIPRAP FAILURES	None noted.

1. The spillway control section (weir) should be repaired.
2. A detailed study, including a stability analysis, should be conducted by a registered professional engineer knowledgeable in earth dams to evaluate the seepage, movement of the walls in the valve house and possible downstream slope instability. The study should include monitoring and testing as required.
